HOWARD COUNTY HISTORIC PRESERVATION COMMISSION

June Agenda

Thursday, June 2, 2016; 7:00 p.m.

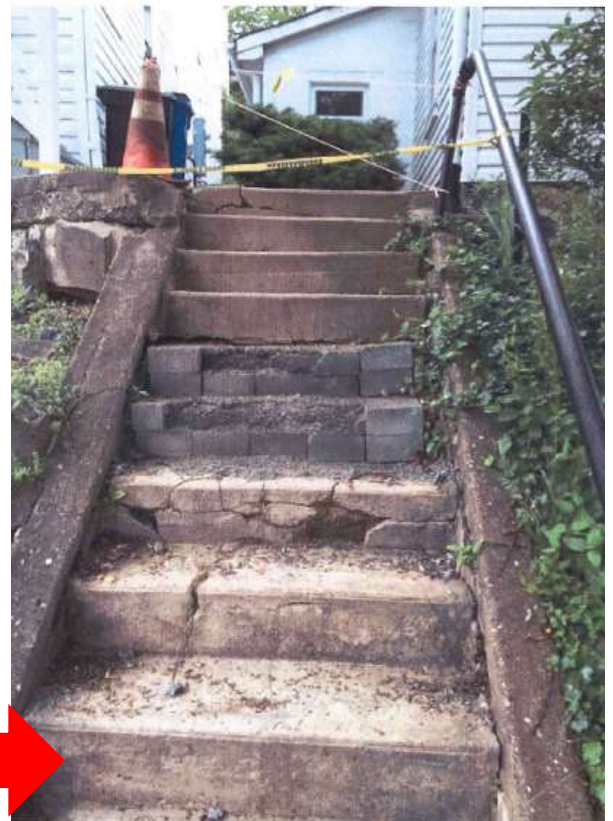
Figure 41 - Looking up at staircase from Church Road

- 5) The second flight of stairs, running perpendicular to Church Road, have cracked and crumbled over the winter and needs to be replaced.

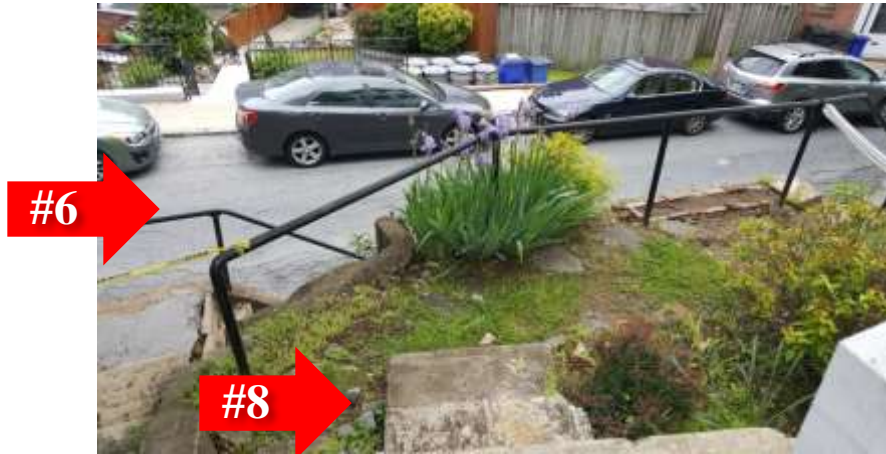
Figure 42 - Area in front of porch

- 7) A cement landing in front of the cottage may also need to be replaced, although it is not as damaged as the other areas.
- 8) Remove old broken cement steps that extend off the main staircase on to the top of the wall that in the garden area in front of the porches.

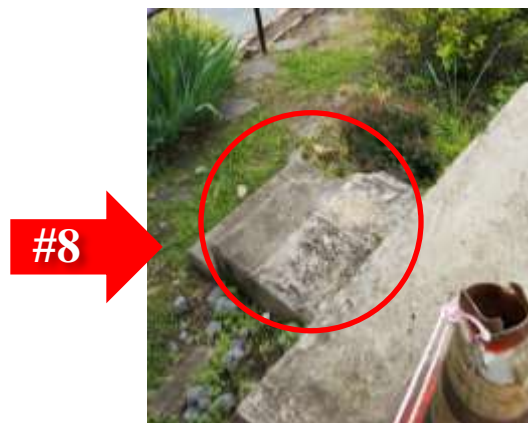
Figure 43 - Old cement steps
